QUTB SHAHI HERITAGE PARK

CONSERVATION & LANDSCAPE RESTORATION

2015
ANNUAL REPORT

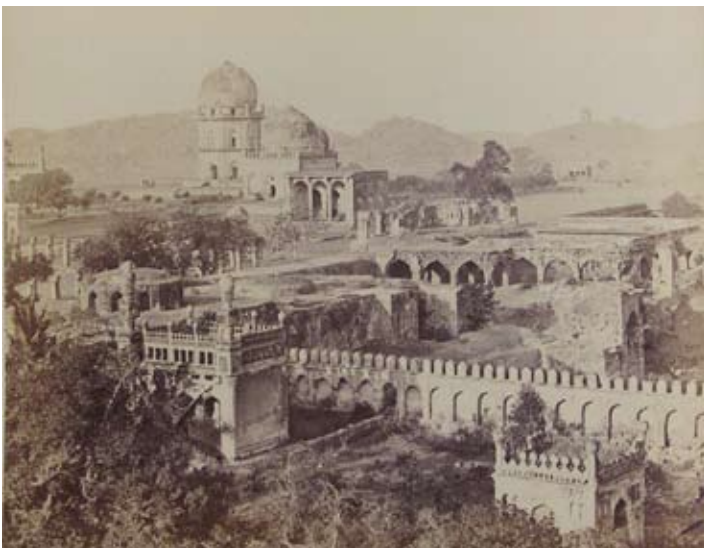
Jamshed Quli Qutb Shah's Tomb and adjoining tombs, early 1860's. The photograph shows the ruinous nature of the principal tomb and indicates that elements such as the finial and the stucco plaster ornamentation is from a later conservation.

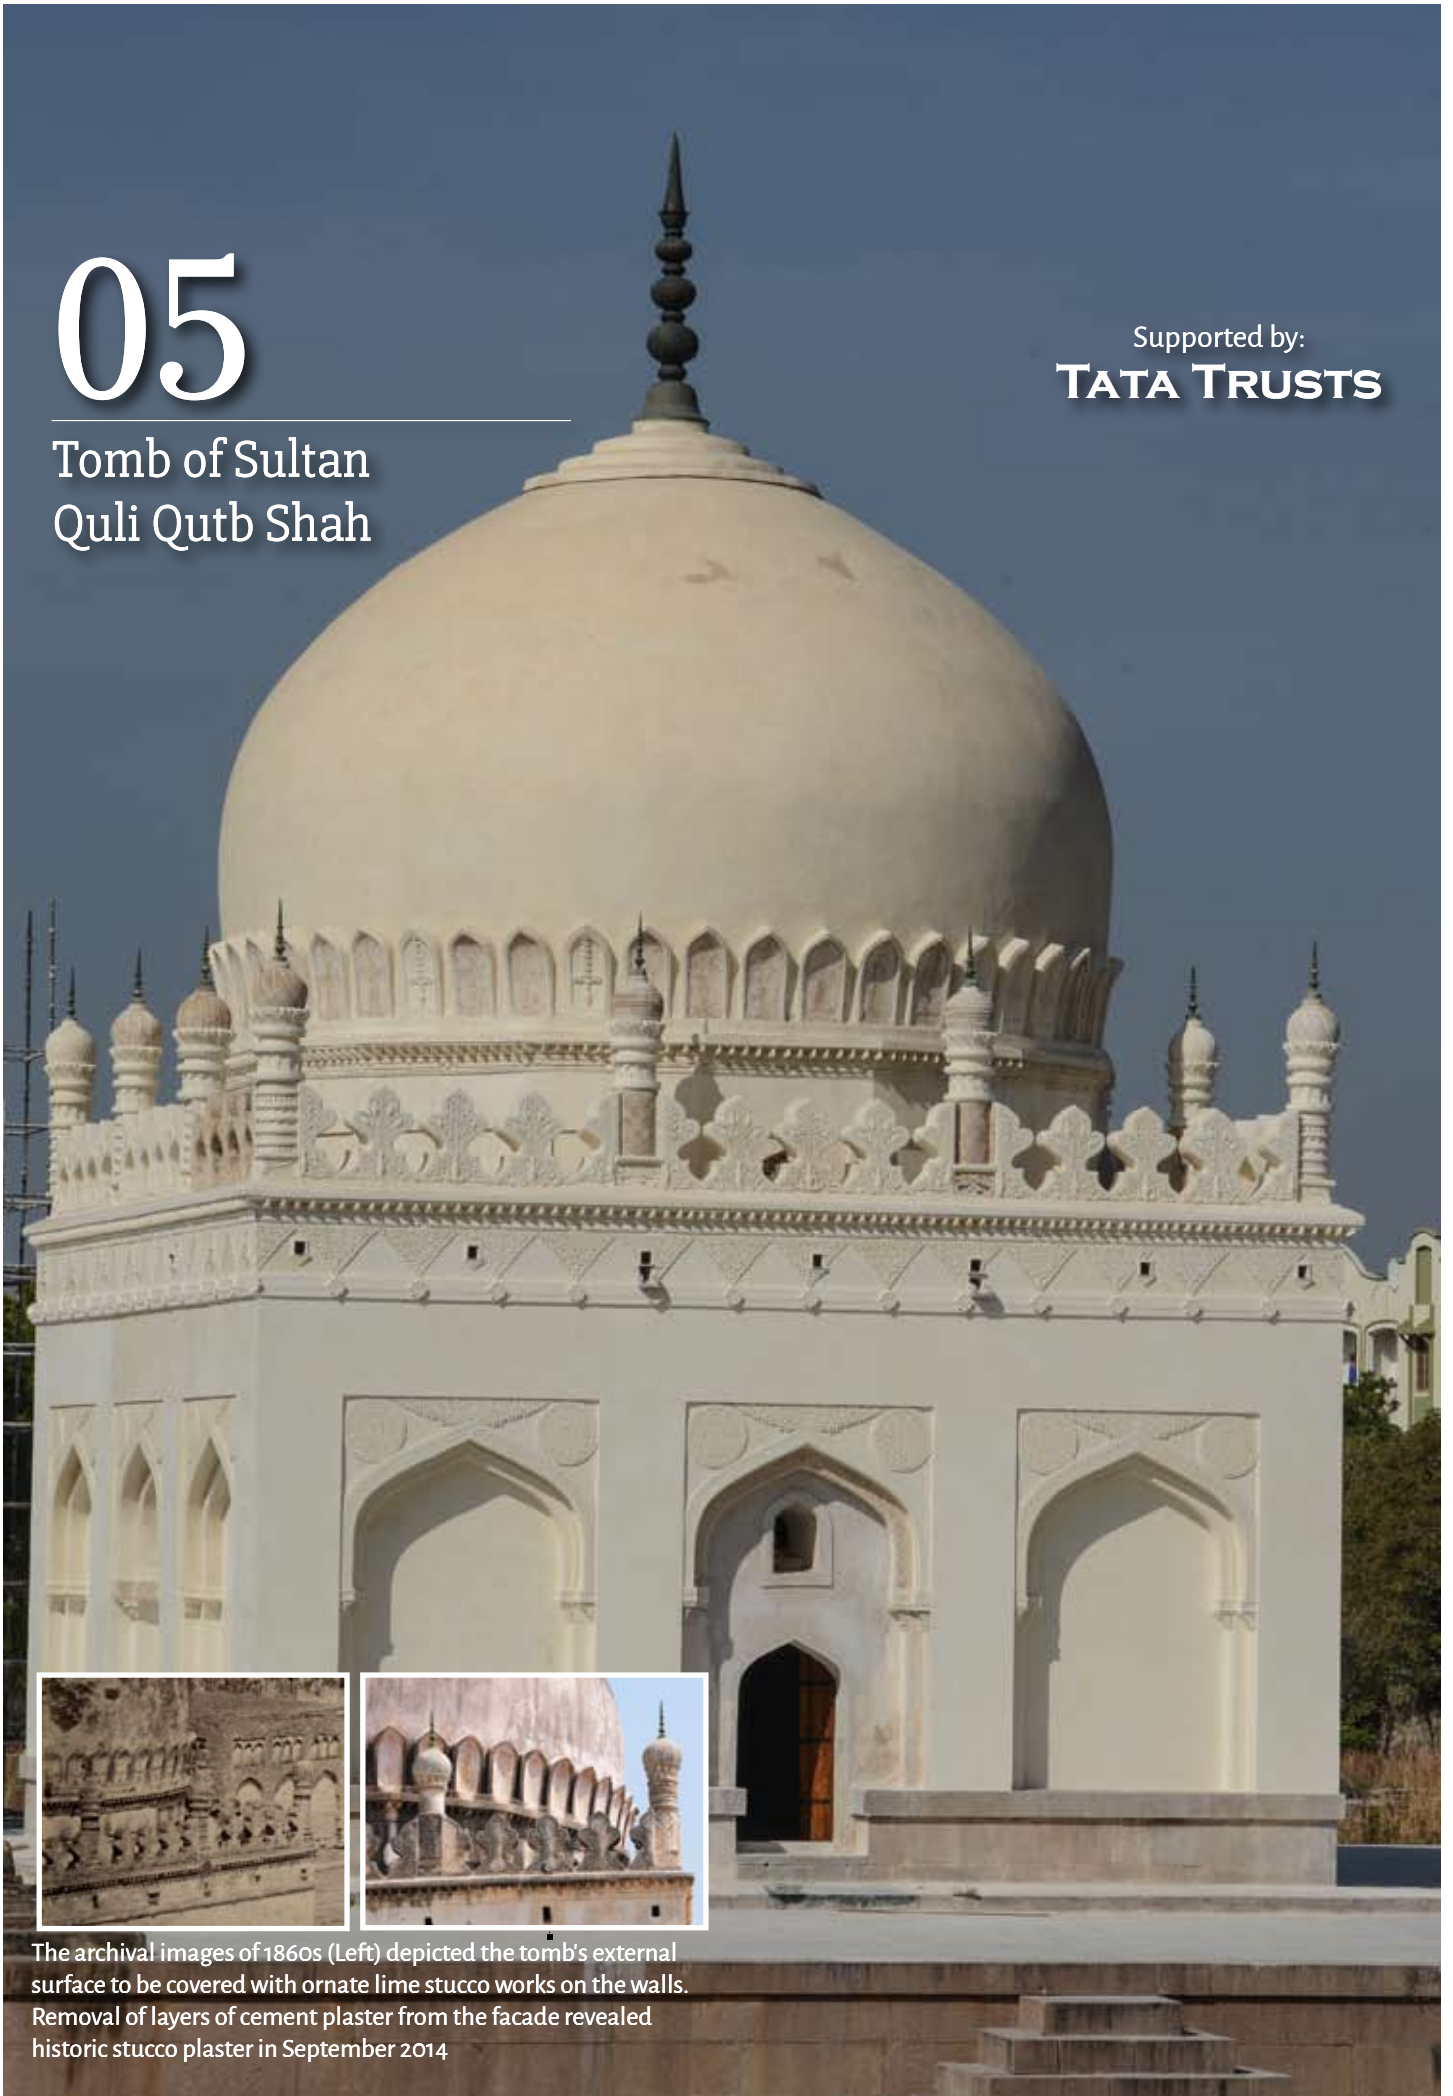
Restoration of Stucco Plaster Patterns

The archival images of 1860s (Left) depicted the tomb's external surface to be covered with ornate lime stucco works on the walls. Removal of layers of cement plaster from the facade revealed historic stucco plaster in September 2014

The scrapping of modern cement layers had revealed distinct patterns on the parapet, minarets, petals on the neck of the dome, arch bands, medallions in the spandrels of the arch, bands below the parapet and remnants of a moulding with bird holes.

- The missing portions of the details on the domes of the minarets on all the sides were restored to the pattern – vertical bands on the east and west, horizontal bands on the north and south and the corners has spiral bands -as per the existing evidence seen on respective minarets.

- The ornate band and mouldings below the battlements were recreated based on the archival image.
- The bird holes which form important feature of this monument, but also were reasons for water ingress to the building due to damaged mortar, have been grouted, repaired and restored as original ensuring no further internal damage to the structure.

- Over 1500 man-days of work by master craftsmen was required to restore the lime stucco ornamentation on the external facade.
- Appropriate wooden doors have been fixed to the arcaded openings.

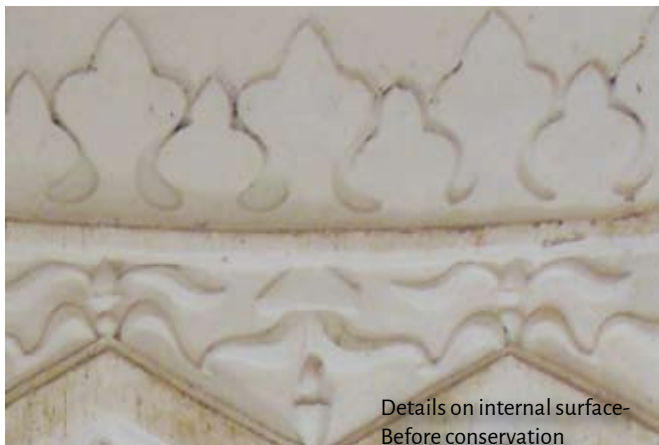
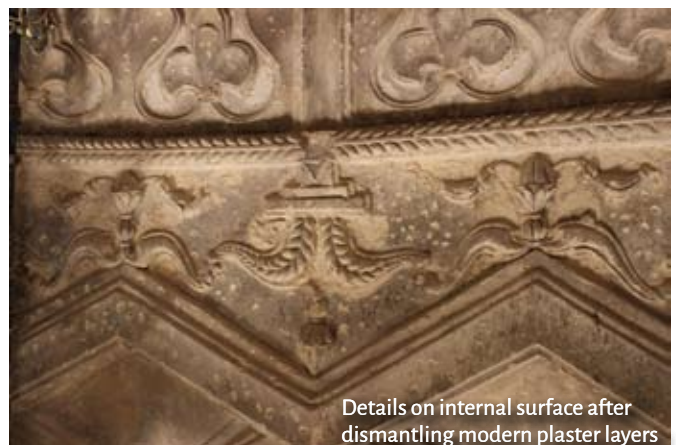
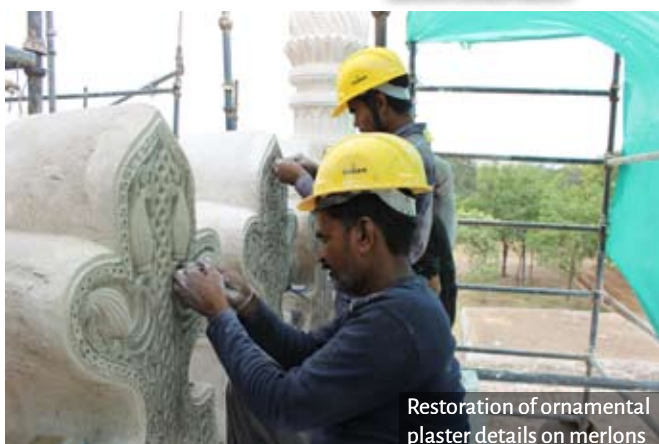
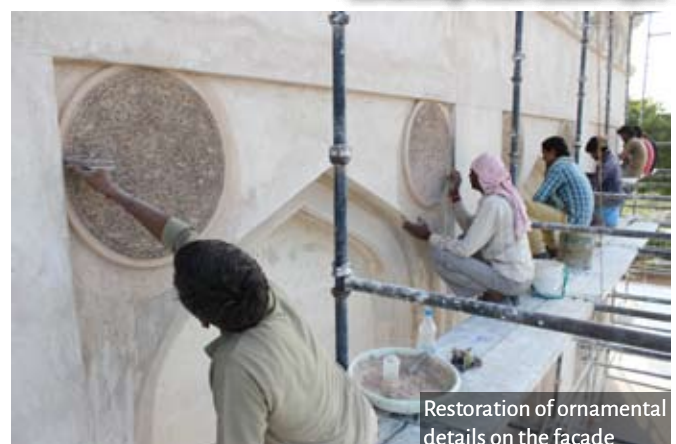
Conservation of the Plinth and Graves

As with most structures in the Qutb Shahi Heritage Park, the plinth was provided only with a layer of cement concrete – allowing water ingress and growth of vegetation and thus catalysing deterioration. Several gravestones stand on the plinth and in many of these stones had dislocated from their original position.

*Careful cleaning of the facade and internal surfaces revealed the underlying original lime stucco as well as incised plasterwork on the Tomb of Sultan Quli Qutb Shah, which were restored in 2014.
(Below) Cement concrete flooring on the plinth replaced with 30 mm granite laid on base lime concrete*

- 15 cm thick layer including the top cement concrete was removed from the plinth surface and replaced with a traditional lime concrete base.
- 30 mm thick granite stone slabs were laid atop the lime concrete in lime mortar to provide a water-tight permanent surface. This would also not be susceptible to wear and tear with high numbers of visitors.
- The graves were cleaned of the cement mortar and the dislocated stones were carefully reinstalled with lime mortar.

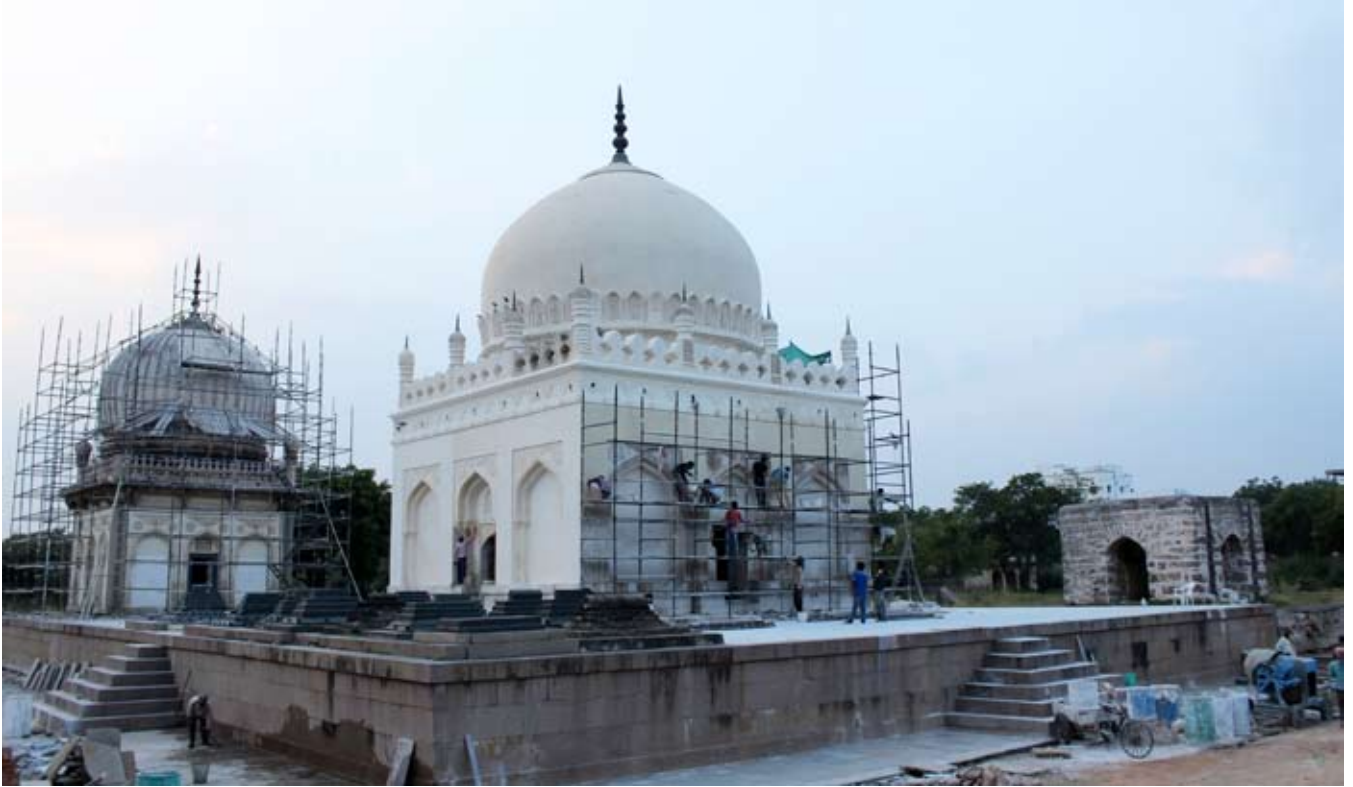
(Above) Conservation works on Sultan Quli Qutb Shah's Tomb required replacing cement plaster with traditional lime plaster and conservation works now commencing on Subhan Quli Qutb Shah's tomb will aim to achieve similar results

- As with the facade, a similar dismantling of cement layers from the internal surface has revealed the original layer of lime mortar. Several details and mouldings which were covered up have been revealed. However, many of the ornate stucco works have been damaged and only outer impression are existing. A thorough study of the lime plaster composition and the details needs to be done prior to commencing conservation works.
- The internal cement flooring is also to be replaced with granite slabs.
- The conservation of the garden enclosure wall followed by ensuring portions can be visible to the public by sensitively lowering ground levels during landscape works.

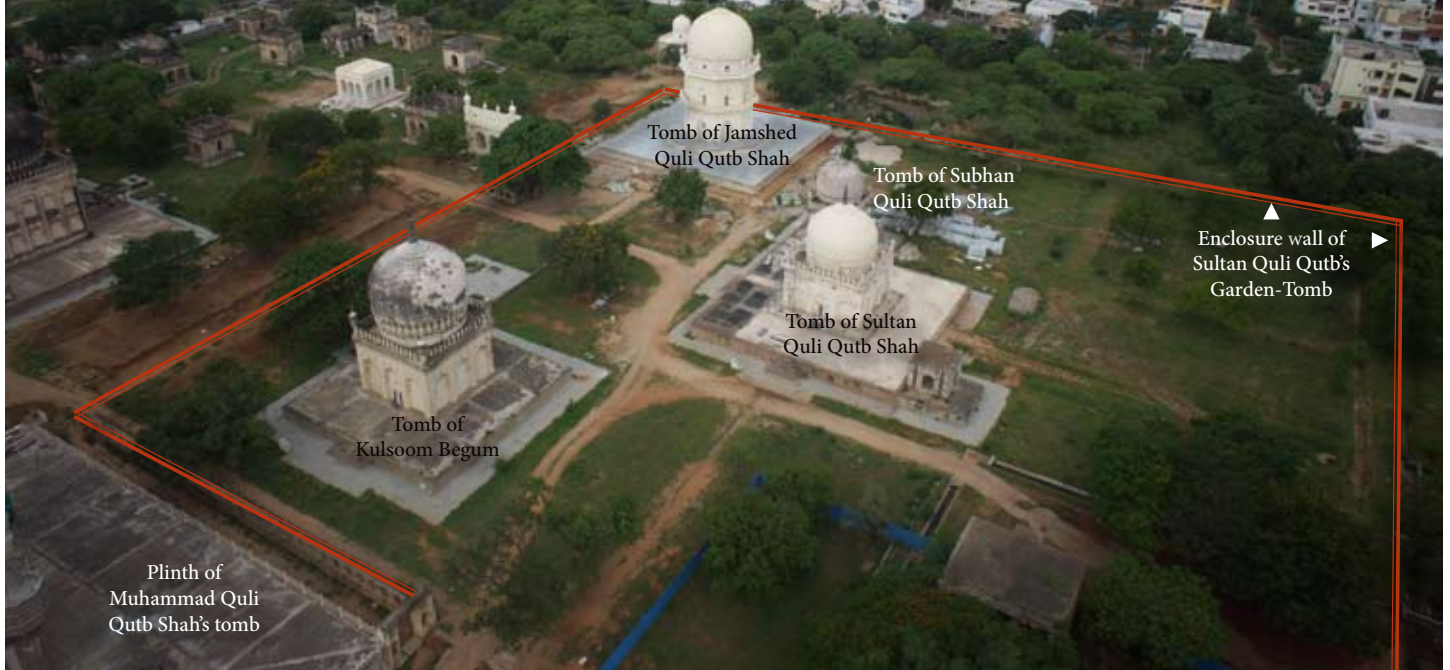
Garden Enclosure

Following the arcade visible to the west of the Tomb of Muhammad Quli Qutb Shah, trial excavation pits were made in 2014 revealing the existence of an ashlar masonry wall with the Tomb of Sultan Quli sitting at the centre of the enclosure, establishing the existence of an enclosed tomb garden with the ashlar masonry going as deep as 2.8 meters along the southern side.

- In 2015, extensive manual excavations were carried out to reveal the entire length of the enclosure wall – over 560 m - exposing upto 1.5 meters depth of the wall.
- The entire south and south – west side of the enclosure wall was revealed upto the Baoli to the west of the tomb of Jamshed Quli.
- Excavations on the west side of the enclosure revealed the missing portions of the wall which had signs of existence of the ashlar wall.
- On the north side of the enclosure, stones wall was damaged and many of the stones were missing from the wall.
- The excavations revealed the profile of the wall – ashlar masonry wall with coping stones on top and a masonry arcade standing above it.

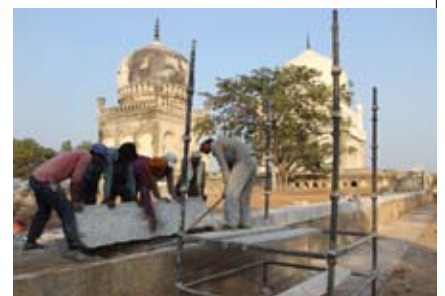
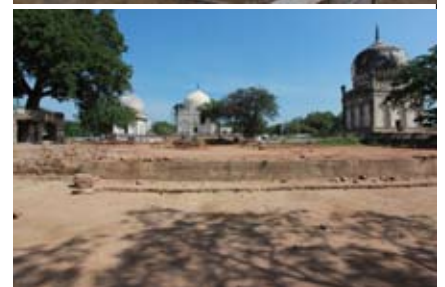
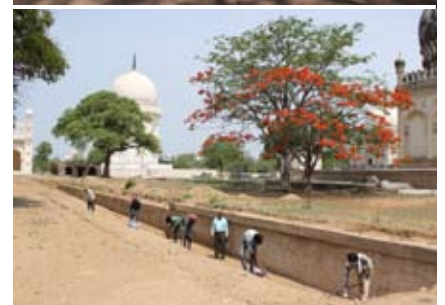
(Above) Stone-carvers restore the coping stone of the discovered wall; (Centre) Later tombs of Subhan, Jamshed and Kulsoom Begum were also built within the 560 m long wall enclosing the tomb of Sultan Quli; (Bottom) Earth re-graded to expose the 16th century wall

The landscape restoration presently underway at the garden enclosure is based on the archaeological evidence and will include revealing the enclosure wall to the extent and depth possible on all four sides and reconstruct portions of the missing arcade on all four sides to restore the sense of an enclosure. The garden levels to the south of the tomb enclosure have been sensitively graded in a manner that both reveals the enclosure wall and does not disturb the geometry of Ibrahim's garden-tomb enclosure.

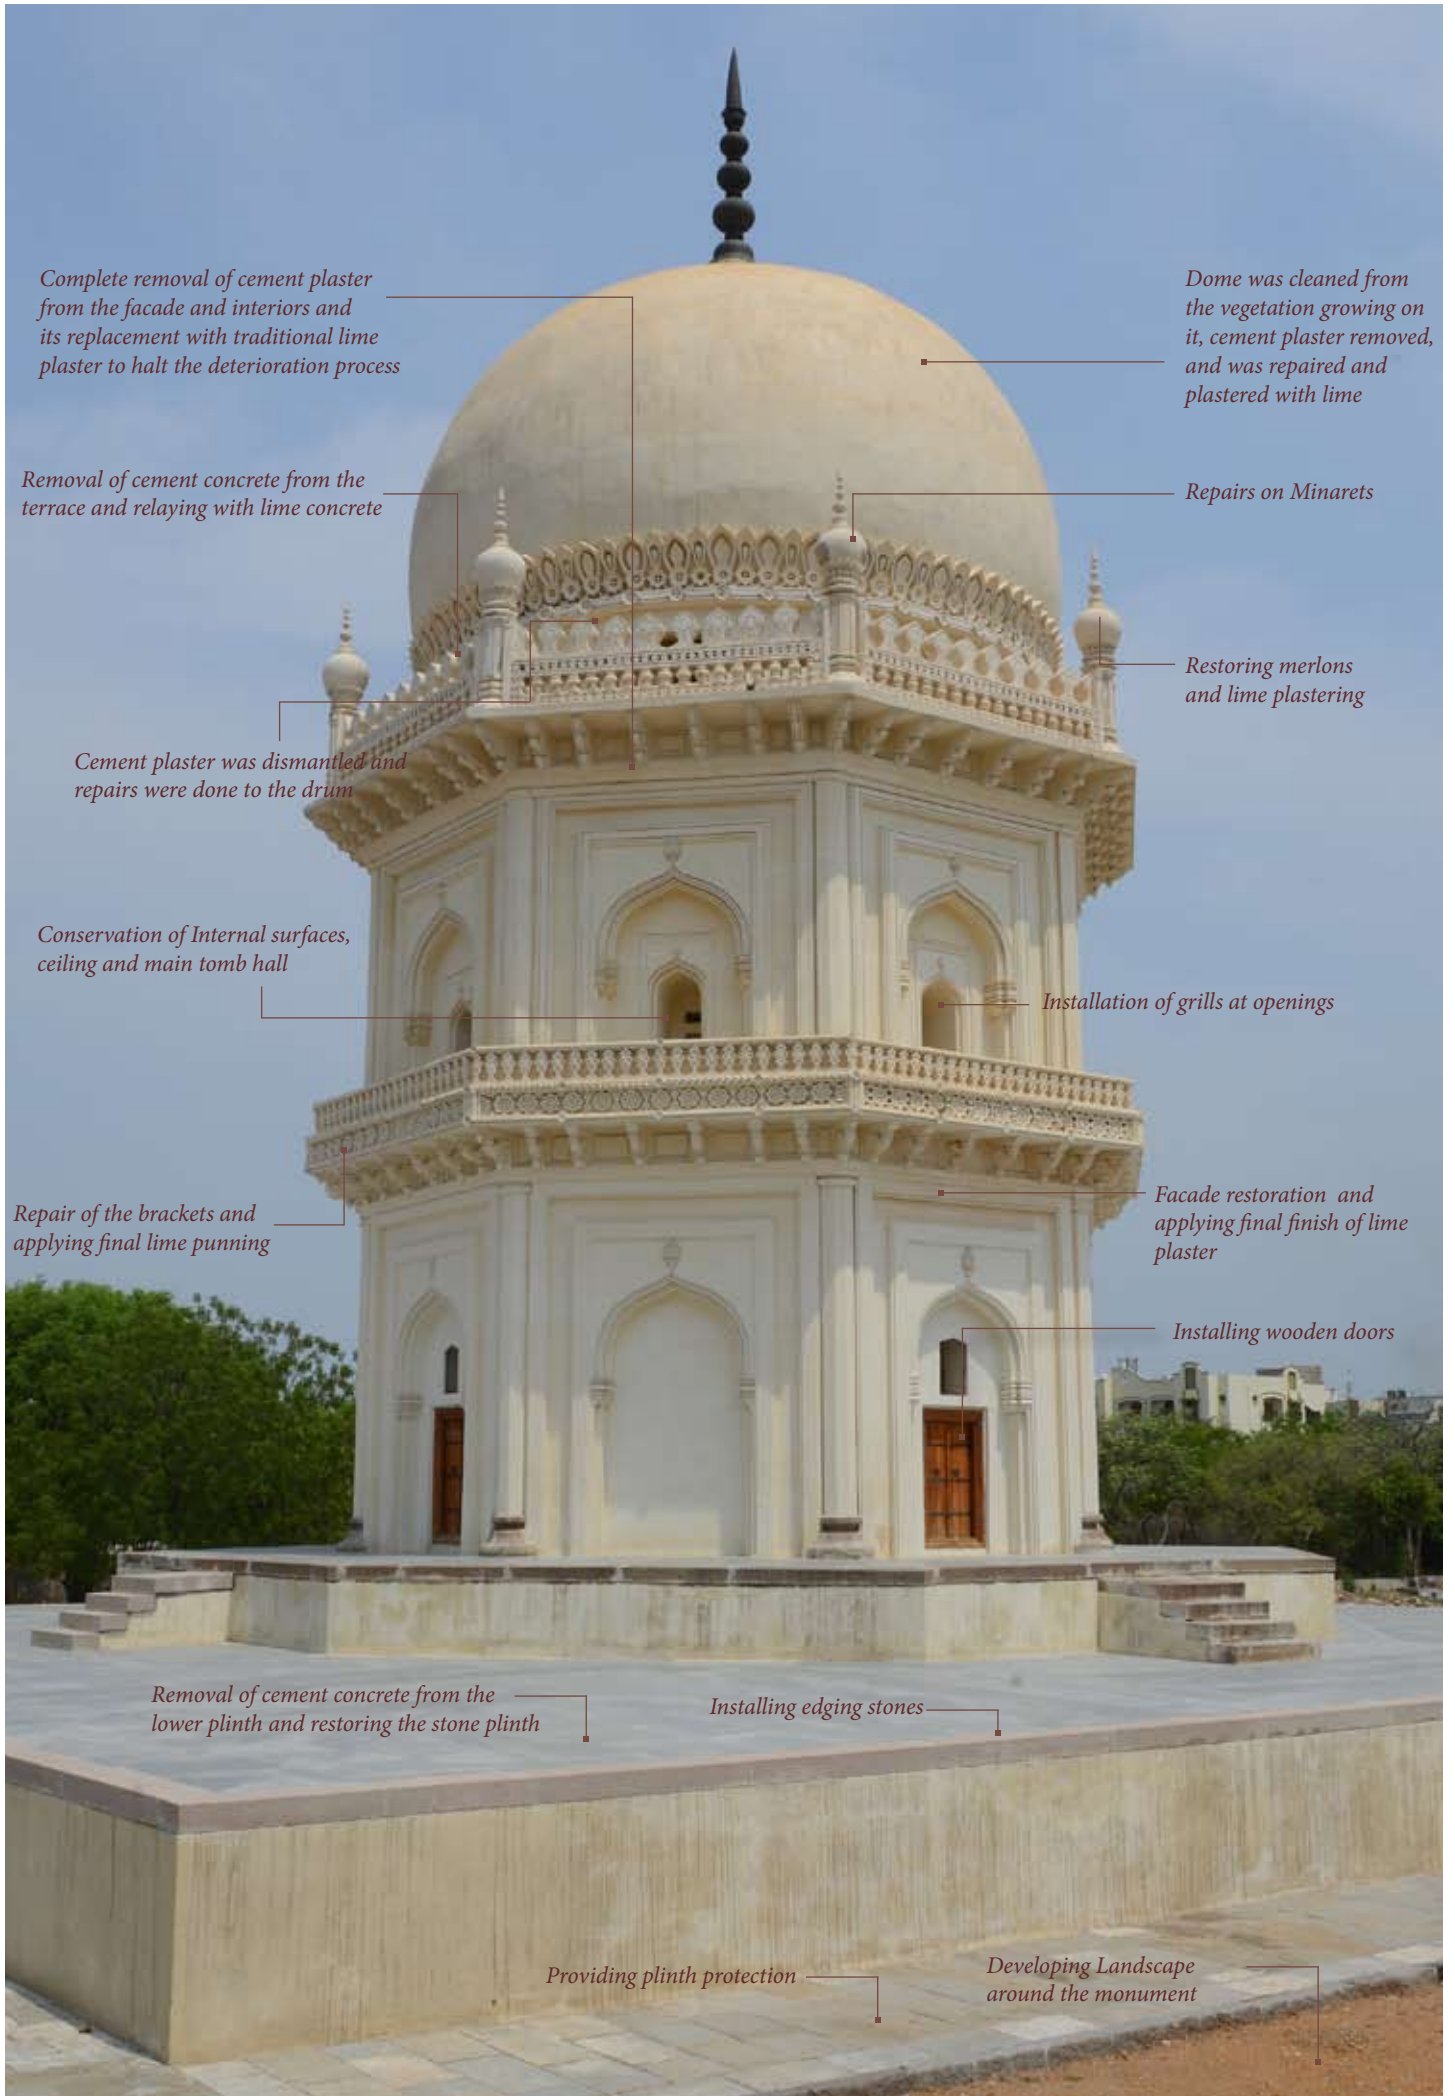
Complete removal of cement plaster from the facade and interiors and its replacement with traditional lime plaster to halt the deterioration process

Dome was cleaned from the vegetation growing on it, cement plaster removed, and was repaired and plastered with lime

Cement plaster was dismantled and repairs were done to the drum

Repair of the brackets and applying final lime punning

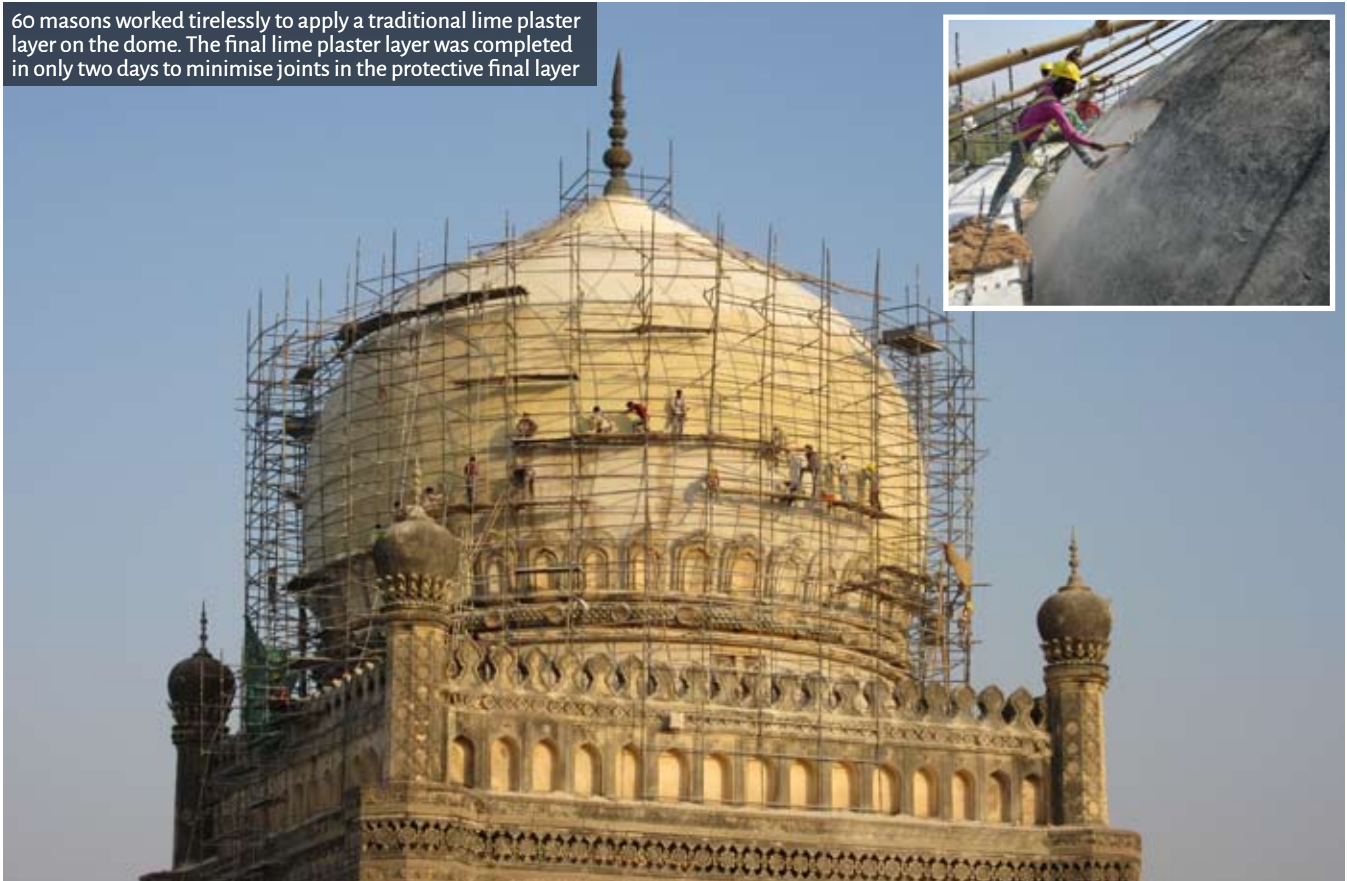
Conservation of the External Surfaces

The external surface below the dome had signs of ageing of the final finish and thin layer of finish was flaking at several portions. Modern repairs had been carried out in cement which led to further damage to the underlying lime plaster. Vegetation growth was also seen in many portions of the surface.

- After cleaning the monument manually using brushes and water, any loose plaster and cement was dismantled
- The battlements were repaired and restored using traditional lime mortar.

- The four corner minarets 7 m tall were also repaired and covered with a final finish of lime plaster.
- The intricate flower bands, arch details were restored by master craftsmen with traditional lime mortar.

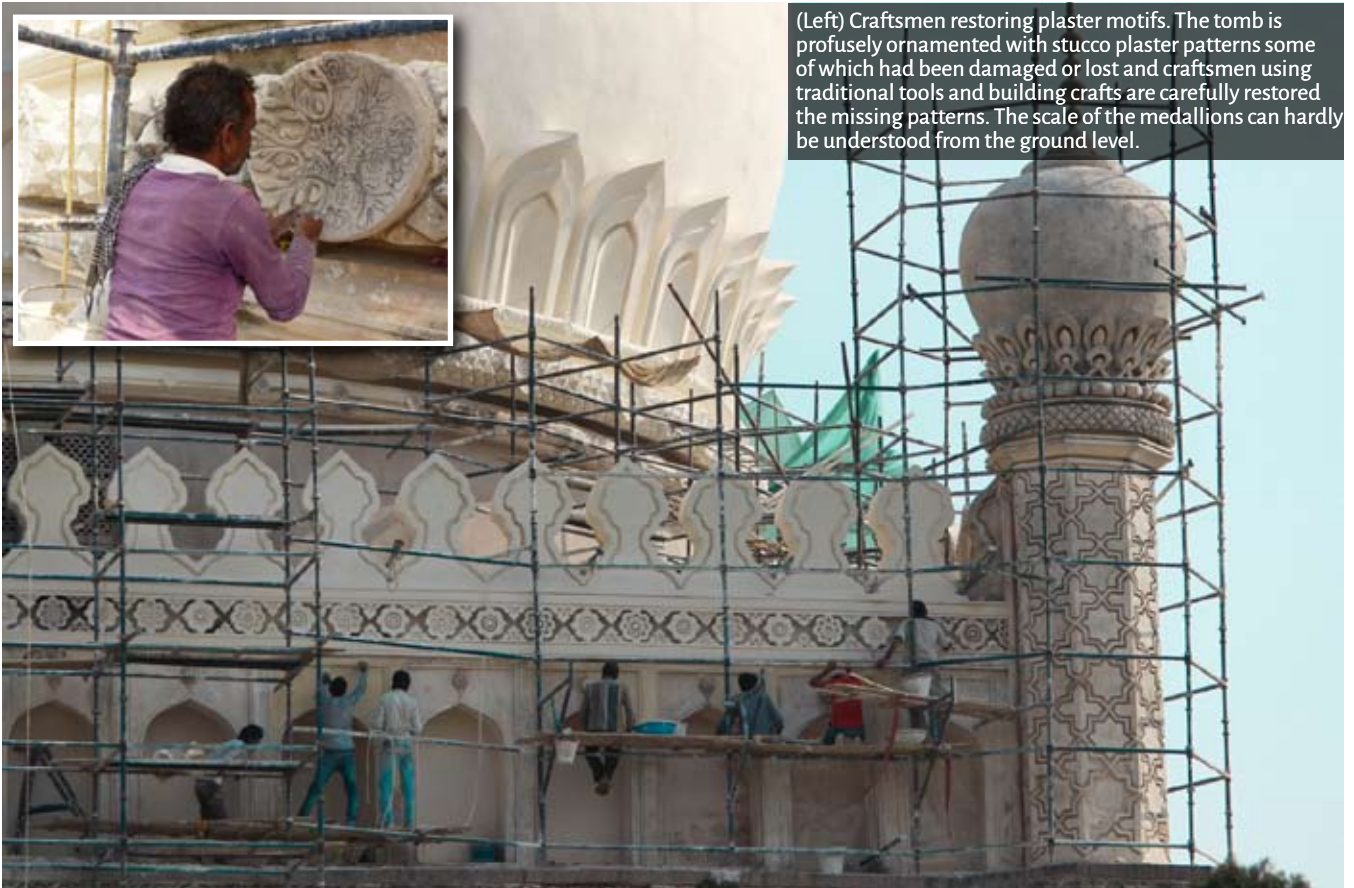
(Left) Craftsmen restoring plaster motifs. The tomb is profusely ornamented with stucco plaster patterns some of which had been damaged or lost and craftsmen using traditional tools and building crafts are carefully restored the missing patterns. The scale of the medallions can hardly be understood from the ground level.

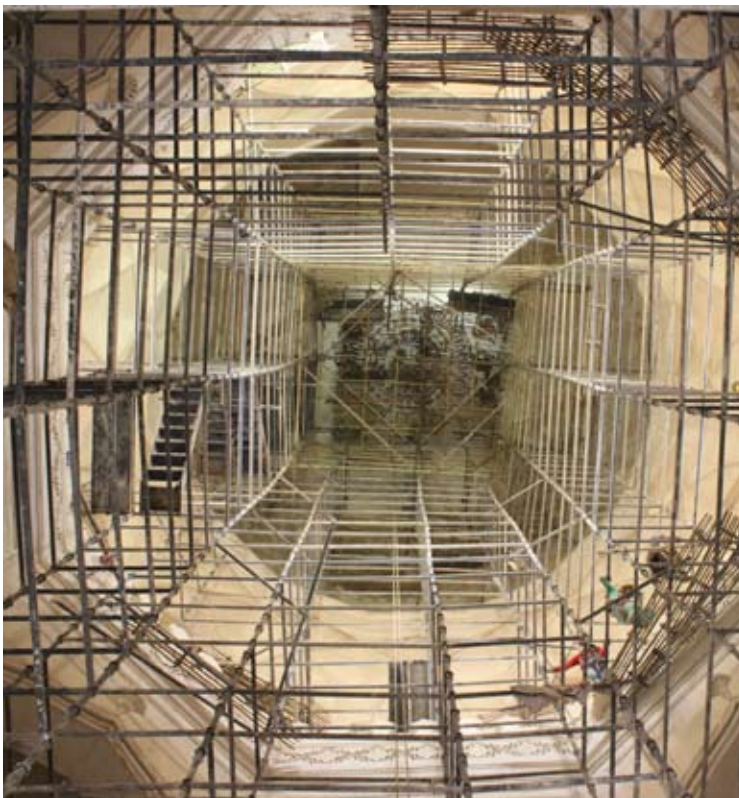
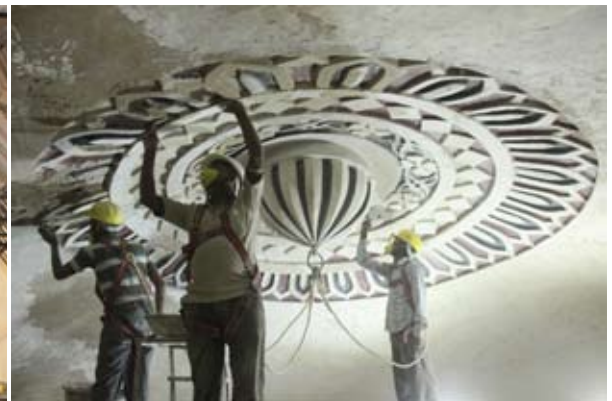
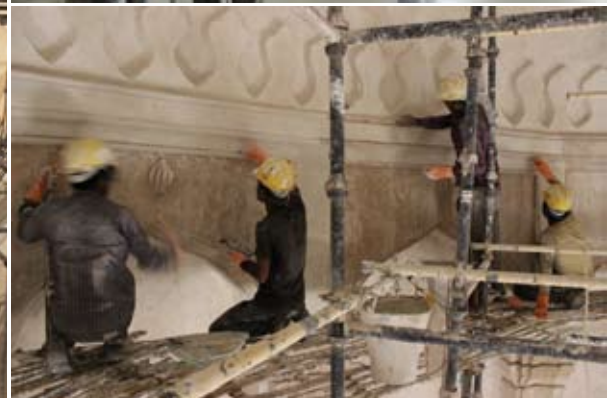
- On investigation of the loose plaster at the cenotaph level, original details were found to be covered with cement thereby altering the original patterns of mouldings and stucco.

*(Left) Restoration of the Main Hall required extensive scaffolding in this tomb chamber - equivalent to a five storeyed building;
(Top Right) Restoration of the ceiling medallion; (Bottom Right) Craftsmen applying final finish of lime plaster on internal surfaces*

- From the central medallion on the domed ceiling, the cement and modern paint layers were removed, repaired and restored by master craftsmen using traditional lime mortar and natural colours.

- The entire internal surface was cleaned and scrapped manually and the repairs were carried out at necessary portions.
- The cement screens were replaced with non-intrusive MS grills, thereby restricting the entry of birds as well as allow more light and ventilation into the monument.

- The 96 merlons atop the series of arches were documented to detail and carefully conserved with minor missing portions restored.
- Original details at the main cenotaph level were restored as per the evidence revealed on removal of cement plaster. This included arch mouldings, bands, arch crowns restored with lime mortar.

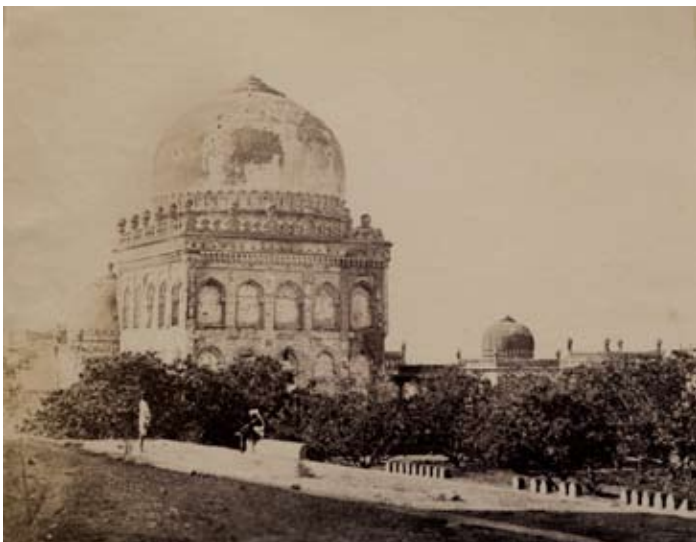
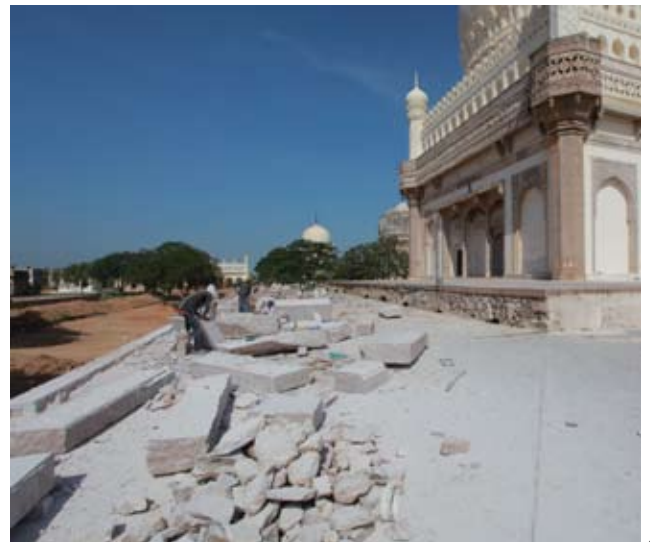
Archival image revealed that the tomb had a stone block parapet similar to that of the Tomb of Muhammad Qutb Shah and Tomb of Hayat Baksh Begum up till the 19th century sometime after which the existing metal parapet seems to have been installed. The stone edging on the parapet was also found to be missing at several portions.

An 1860's view (Left) of Muhammed Quli Qutb Shah's tomb, showed the original stone parapet that was replaced in the 20th century with an iron railing thus disfiguring historic architectural character and authenticity; (Right) At least 20,000 man-days by traditional craftsmen will be required to restore the stone parapet

- The dressed stones will be prepared over the next 12-18 months and fixed thereafter.
- Cement concrete from the plinth needs to be removed and replaced with traditional lime mortar and granite stone slabs ensuring long term preservation.

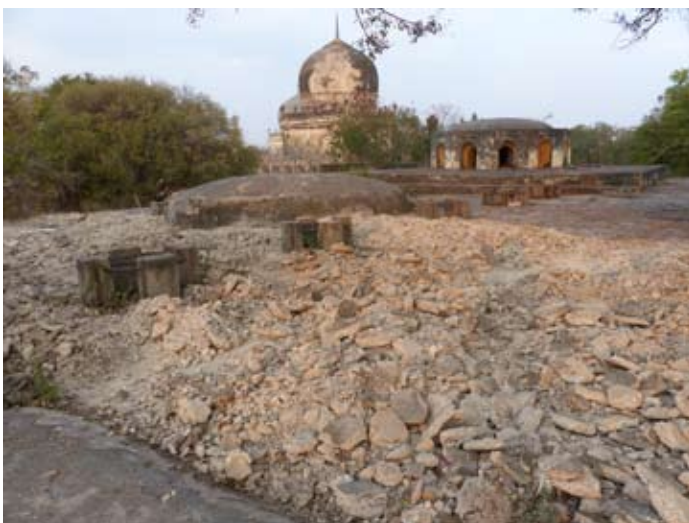
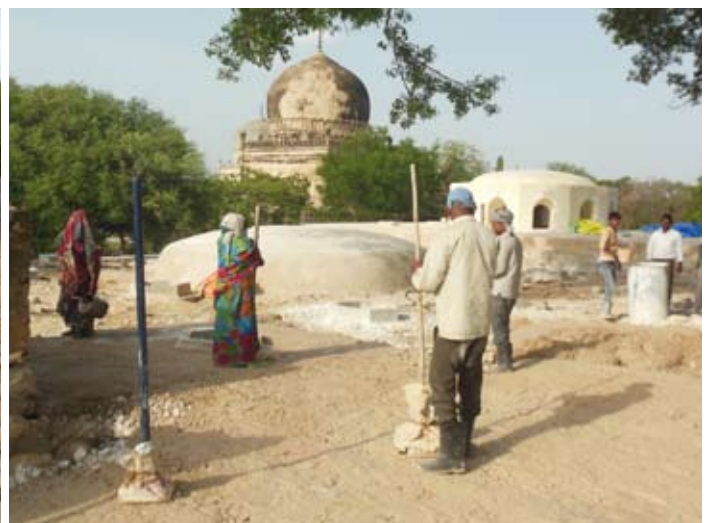
(Left) Removal of cement from the roof; (Right) Laying of traditional lime concrete on the roof after dismantling of cement

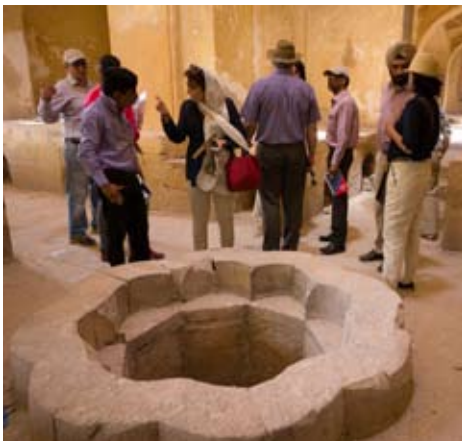
Eastern chamber of hamam after dismantling of modern cement and plaster layers; (Below) Dismantling of cement from the platform of the eastern chamber

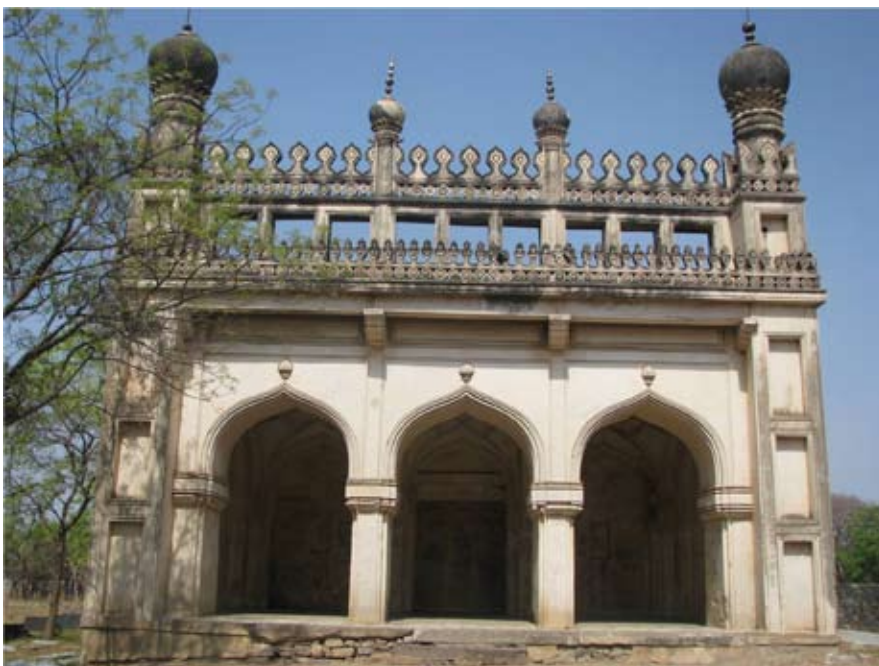
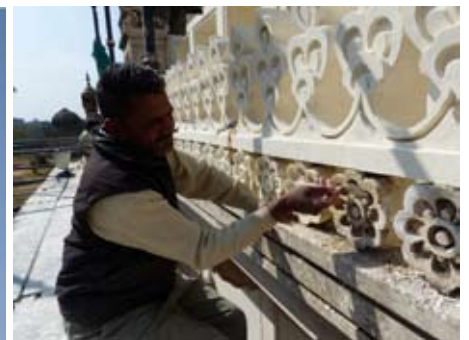
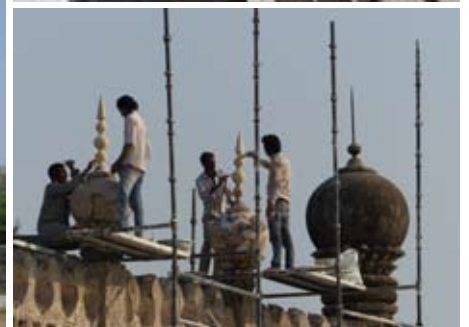
(Left) The Grave Mosque - before conservation works; (Top Right) Repair of ornamental plaster work; (Bottom Right) Restoration of minarets

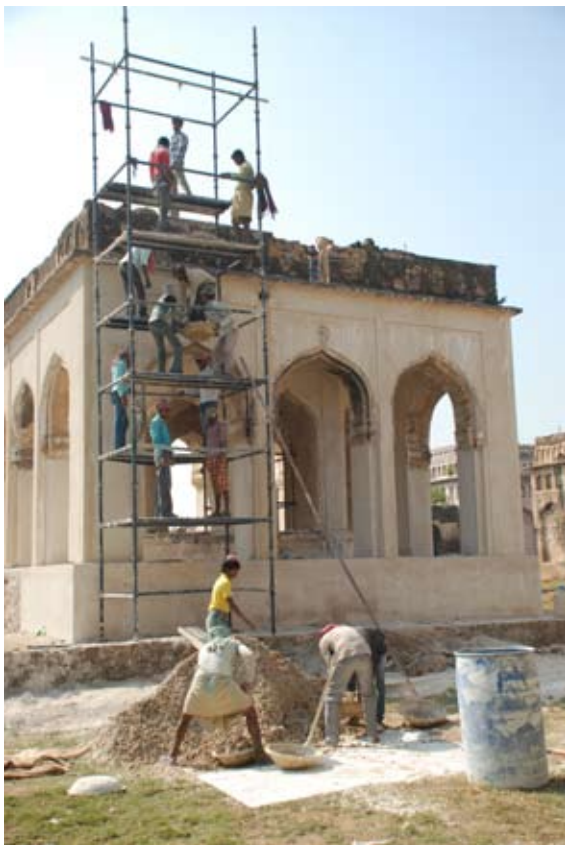
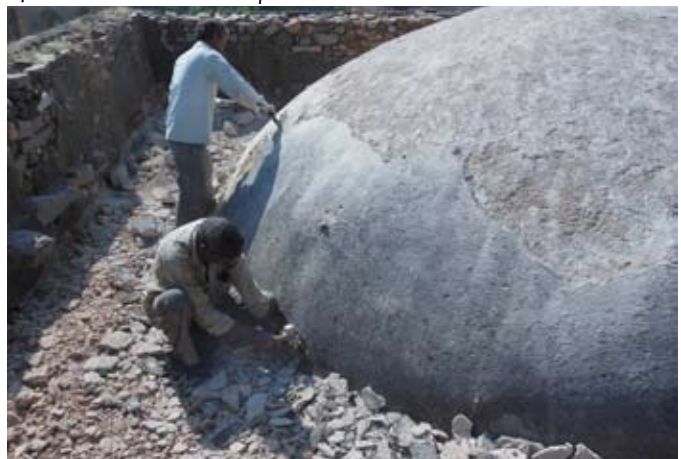
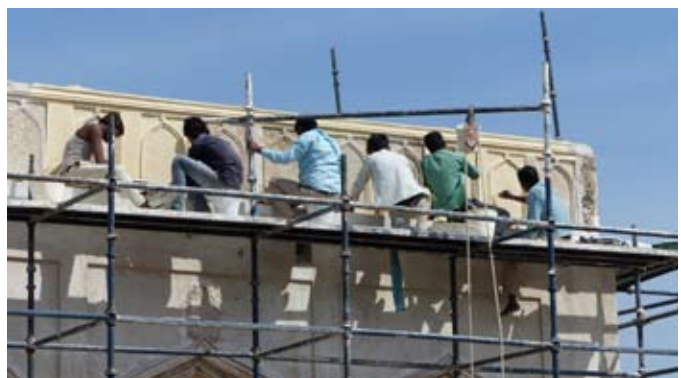
(Left) Tomb No. 15 - during conservation works; (Top Right) Dismantling of modern cement and plaster layers from the roof; (Bottom Right) Restoration of ornamental incised lime plaster details

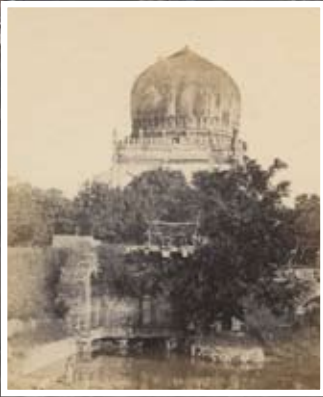
(Above) Archival image of Badi Baoli from 1860's, which shows that as with some of the other step-wells on the site, this too was a simple water tank up till AD 1862. It was later probably by Salarjung I/II, that the arcade was added – - Source: Alkazi Foundation; (Right) Conservation works in progress after the collapse of Baoli wall in 2013.

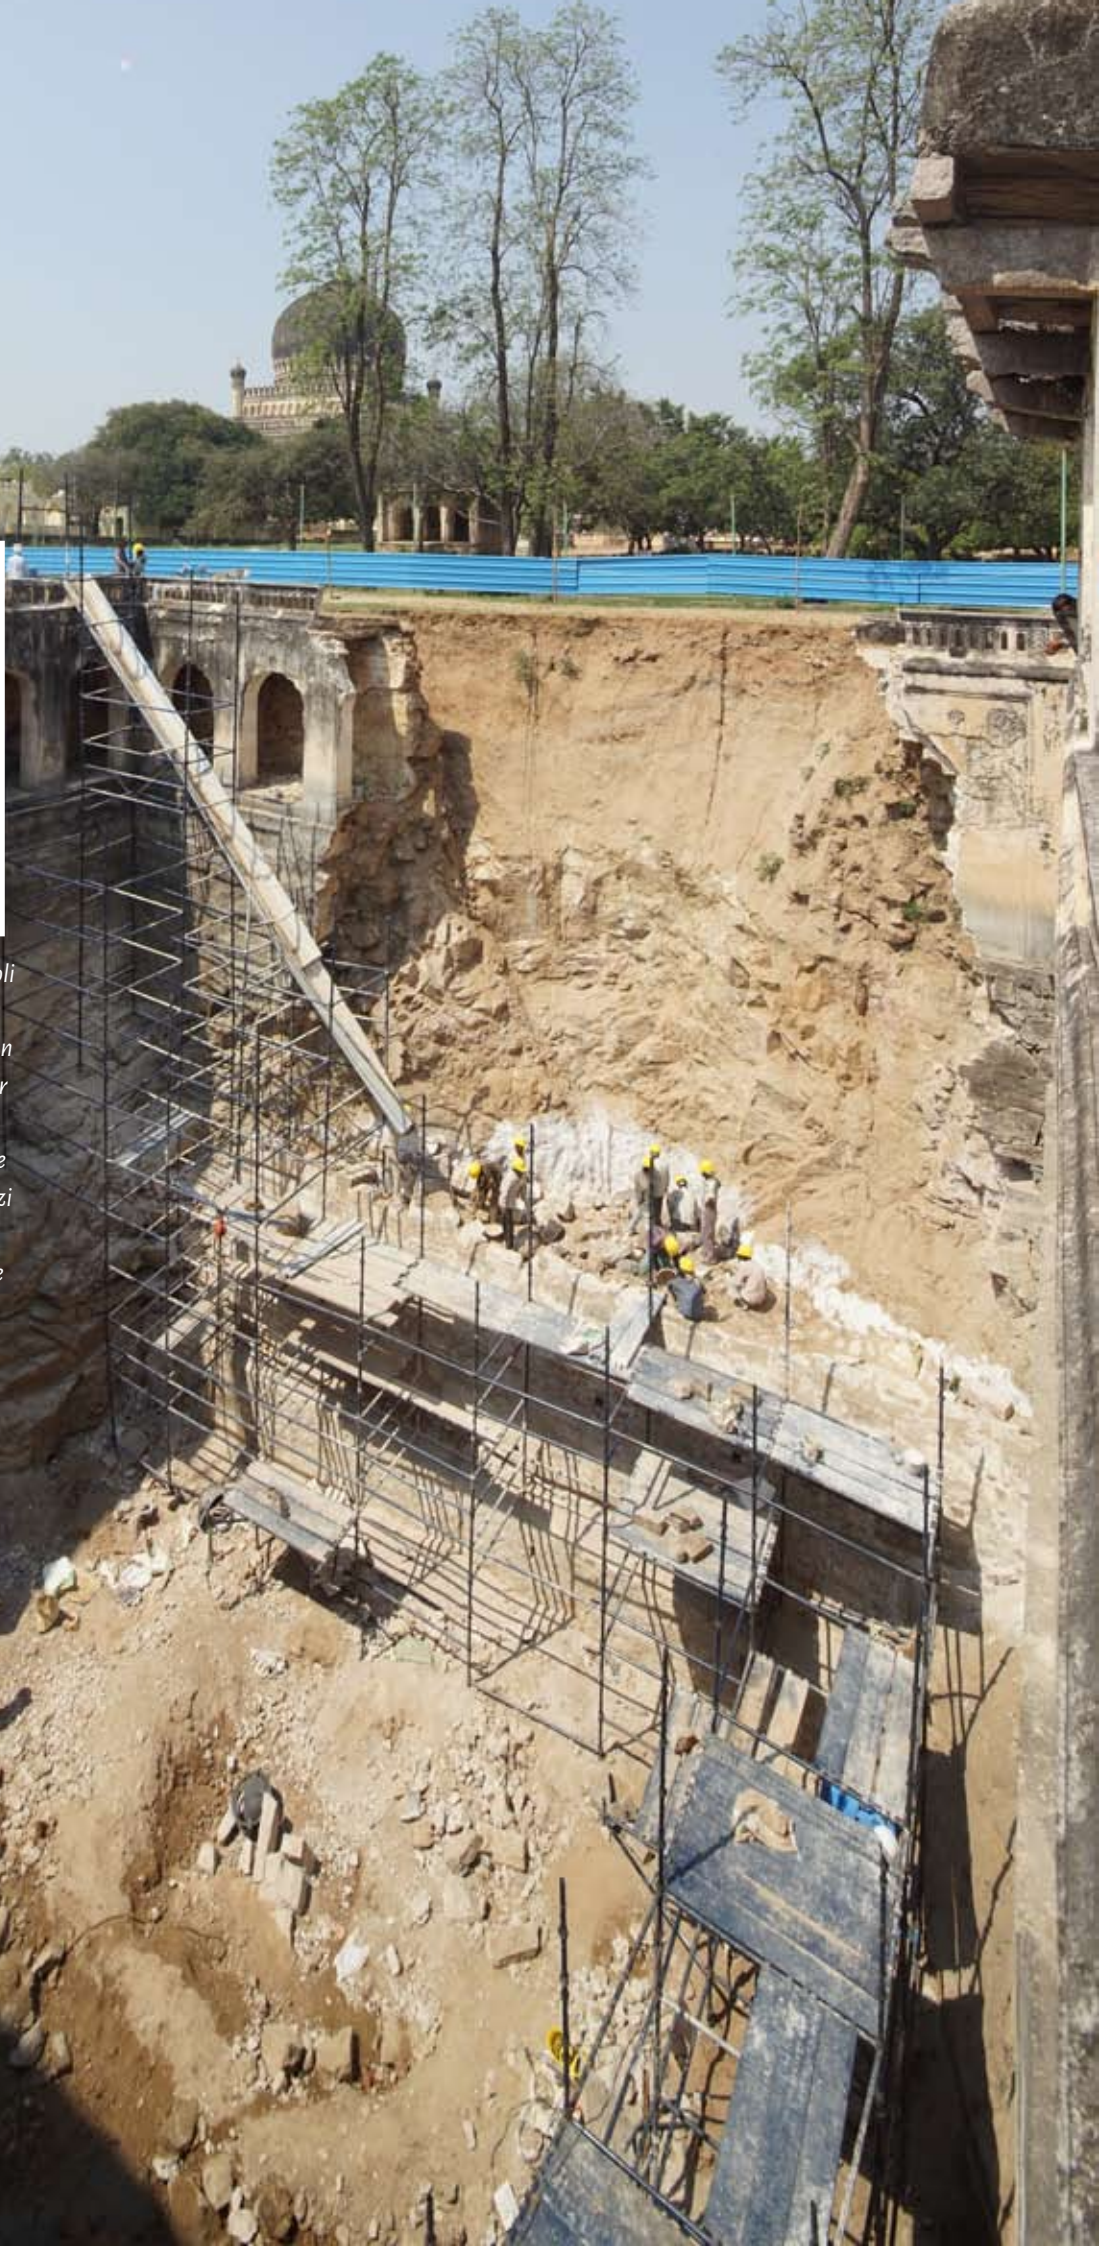
◀ Re-construction of the collapsed wall in 2014-15 to prevent further collapse
